RECOVERY OF MILL RACE GROUND MOTION CANISTERS AND EXAMINATION OF CANISTER EMPLACEMENT

Technical Report

The purpose of this report is to document the efficacy of the gauge emplacement technique used in the MILL RACE Strain Path experiment through postshot examination of gauge canisters.

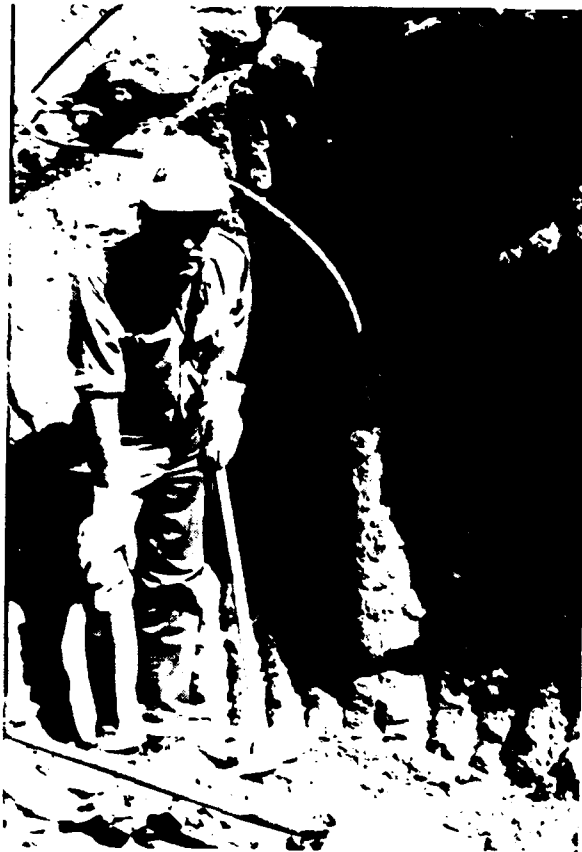
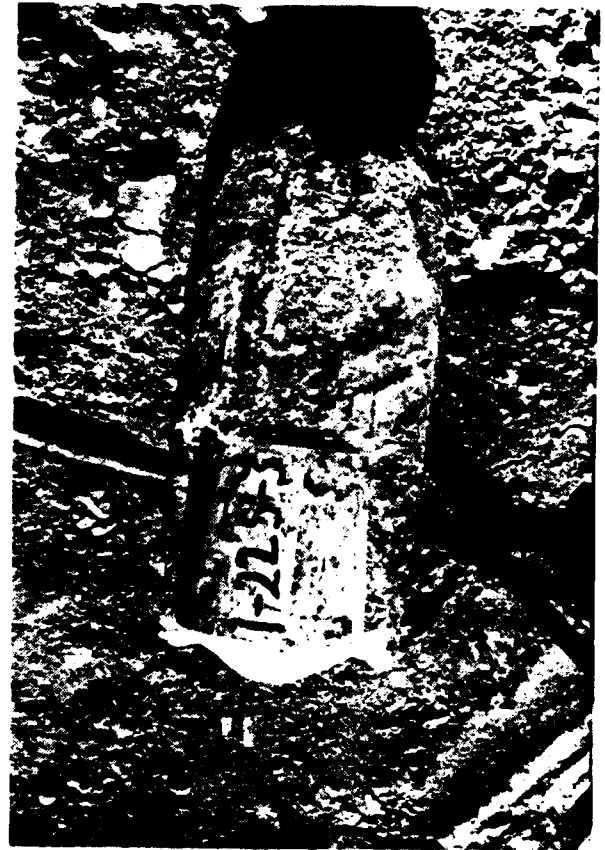
Figure 9. The 1-225-3 canister, partially and fully excavated.

1-225-3: The canister was roughly 50% exposed. Its entire bottom was exposed, indicating that a large amount of soil had fallen into the bottom of the hole partially burying the canister before the grout was pumped in. About 180 degrees of the canister wall is exposed and there was a moderate sized void on top of the canister on the same side as the exposed bottom. This would indicate that soil had fallen into the hole around the canister before the grout was being pumped in. The grout was strongly bonded to the canister wall and to the surrounding medium. The soil in contact with the canister wall had also bonded to the canister.

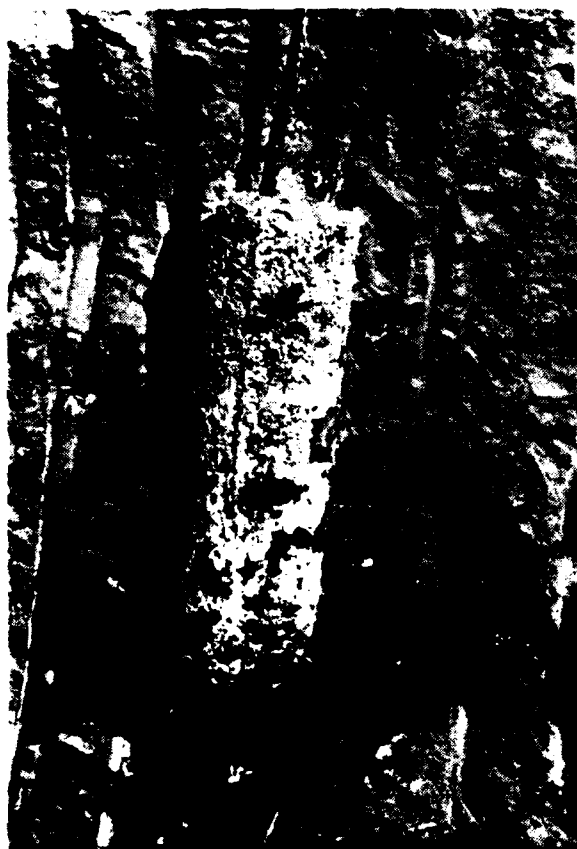
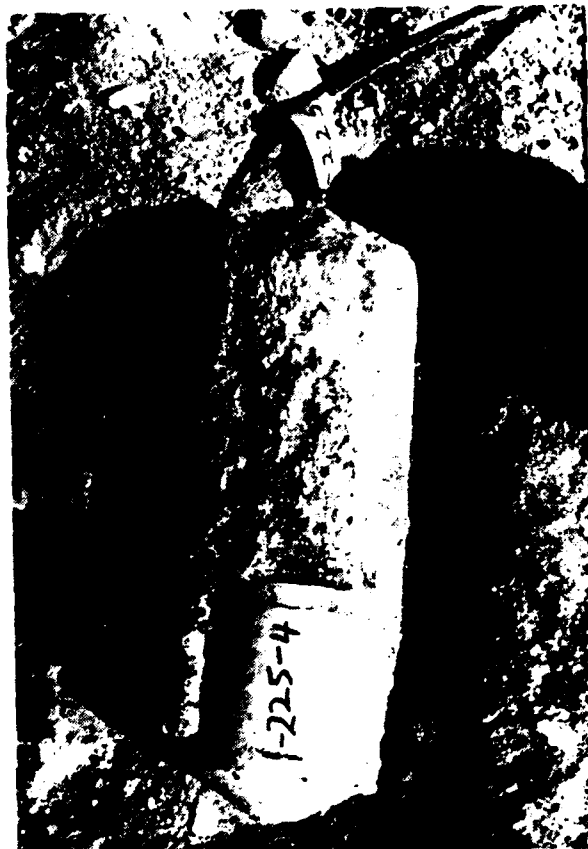
Figure 10. The 1-225-4 canister, partially and fully excavated.

1-225-4: The canister was found to be roughly 70% exposed. The entire bottom of the canister including the wall up to a height of about one inch, and 180 degrees of the canister wall were exposed. This indicates that a large amount of soil was falling to the hole bottom both below and around the canister prior to the arrival of the grouting material. The discontinuous slope of the soil/grout interface at this level suggests that soil continued to fall downhole during the grouting process. In addition, a moderate sized void was observed on the top of the canister where soil had fallen prior to the arrival of the grout. The grout was strongly bonded to the canister wall and to the surrounding medium. The surrounding soil was also bonded to the canister wall.

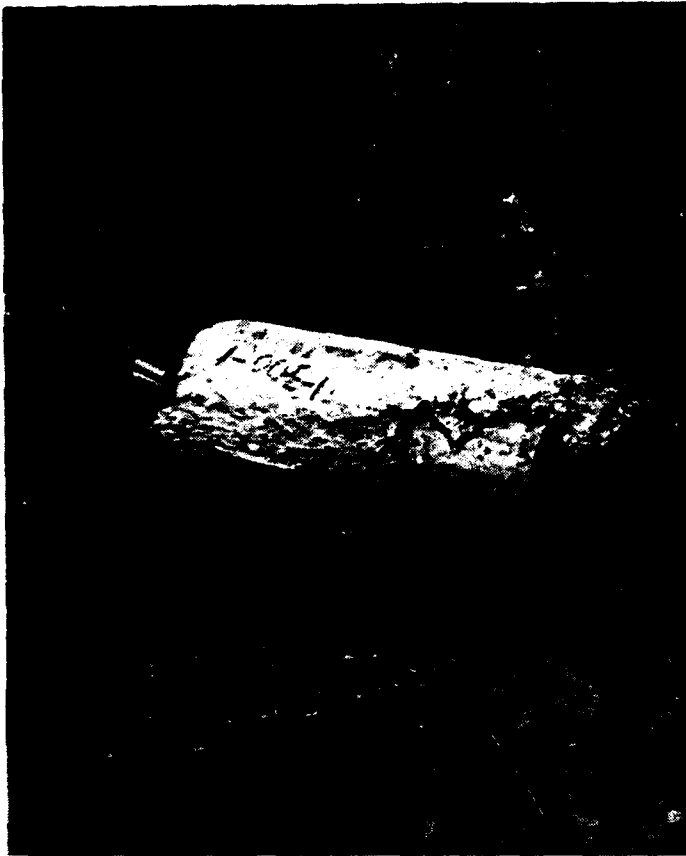
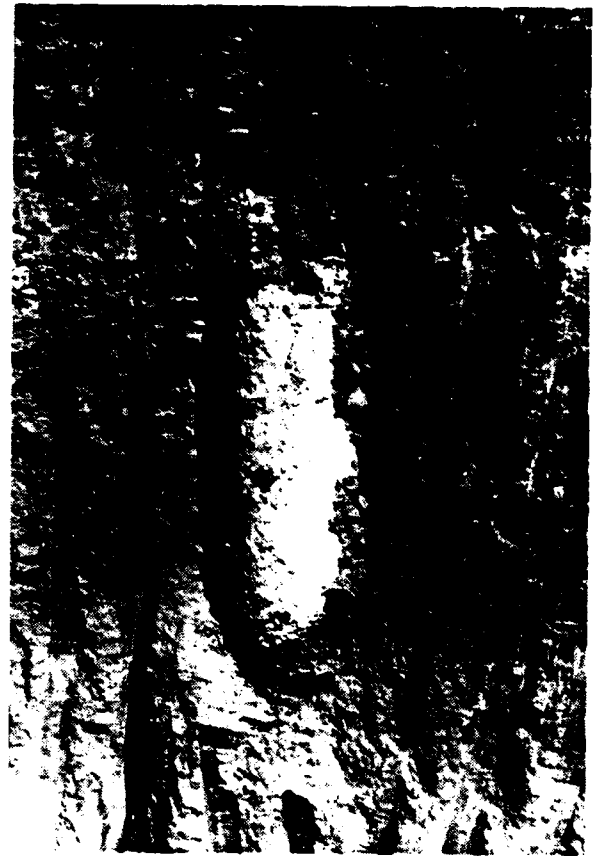
Figure 11. The 1-300-1 canister, partially and fully excavated.

1-300-1: About 40% of the surface was exposed. The bottom of the canister was about 50% exposed with the grout continuing for several inches below the canister bottom. Apparently, there was a substantial amount of soil in the hole bottom when the grout was pumped in; that soil may have been pushed to one side by the falling grout. About 180 degrees of the canister wall was exposed with a small void on the top on the same side. The grout in this case is bonded strongly to the canister wall and to the surrounding medium. The soil in contact with the canister wall is also bonded to the canister.

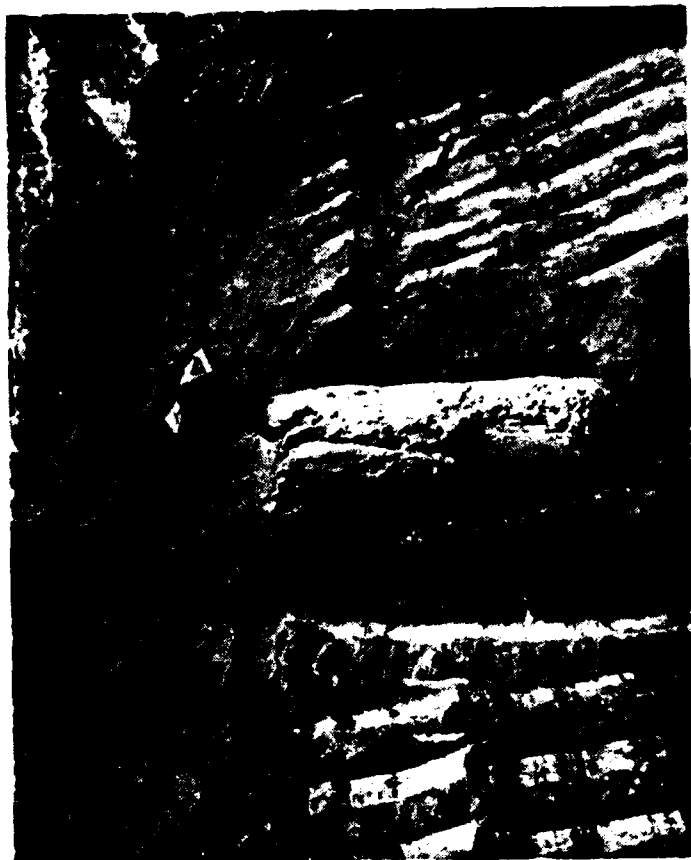
Figure 12. The 1-300-2 canister, partially and fully excavated.

1-300-2: The canister was found to be roughly 30% exposed. The bottom of the canister was about 30% exposed along with roughly 120 degrees of the canister wall. There was also a large void on the top of the canister on the same side as the exposed wall. The observed distribution of soil and grout could have resulted from the fall of soil into the hole before grouting. The grout was strongly bonded to the canister wall and to the surrounding medium. The soil in contact with the canister wall was also bonded to the canister.

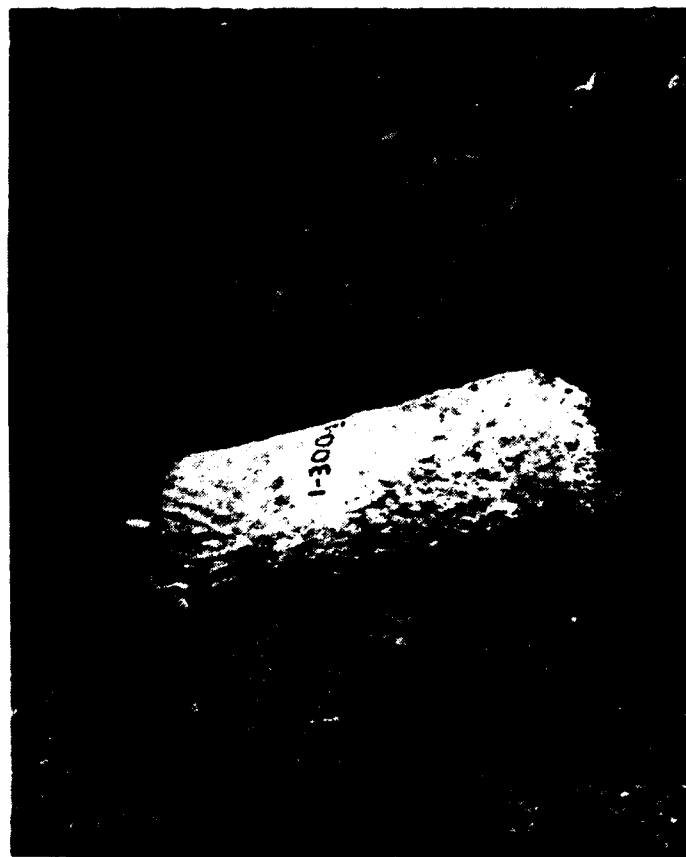
Figure 13. The 1-300-3 canister, partially and fully excavated.

1-300-3: The canister was found to be fully grouted in. There were no exposed areas or voids observed. The grout was firmly bonded to the surrounding medium.

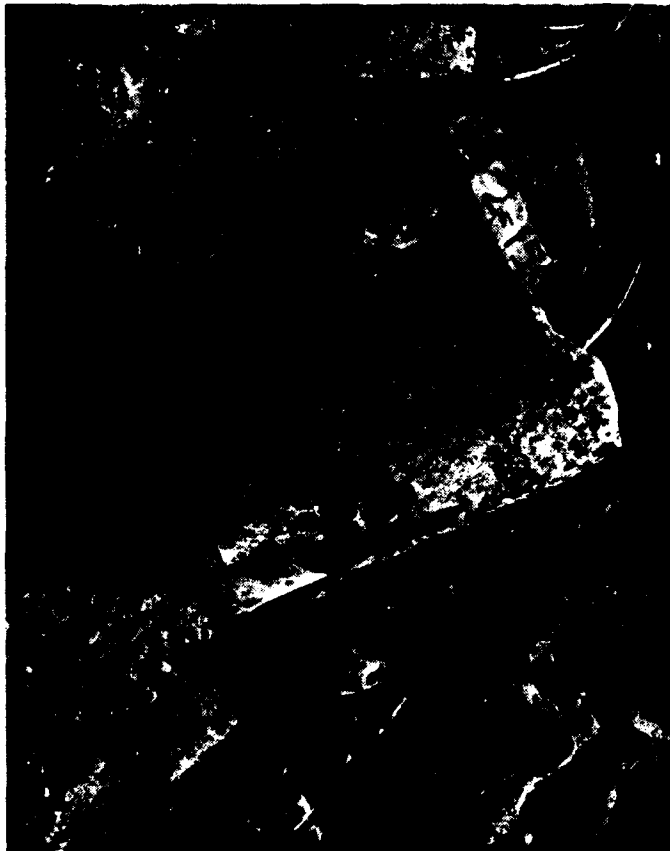
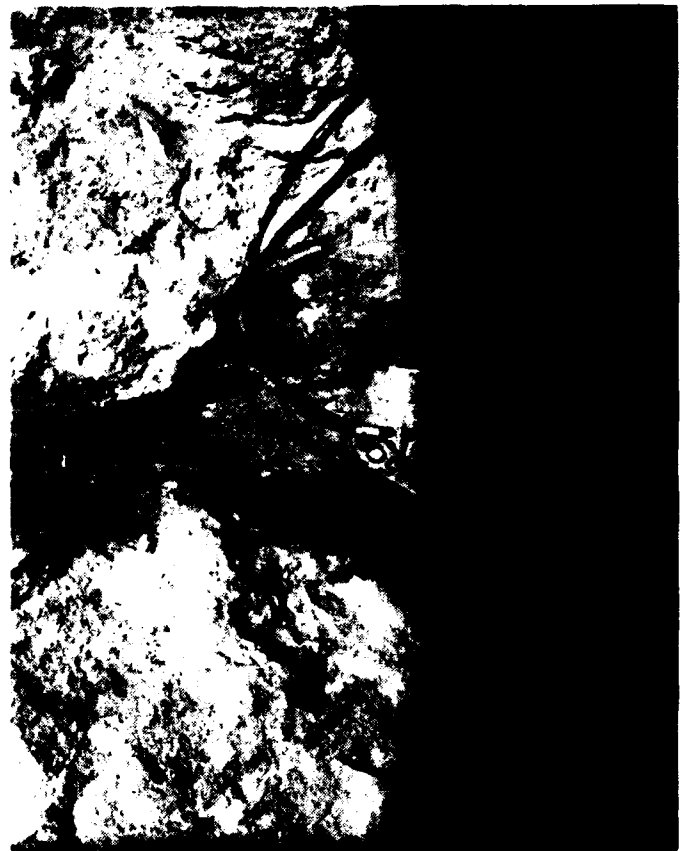
Figure 18. The 2-150-4 canister, partially and fully excavated.

2-140-4: Roughly 35% of the surface was exposed. About 50% of the bottom and 180 degrees of the wall were exposed. There was no sign of voids on the top of the canister and the grout extended for several inches below the canister bottom. It is likely that the observed pattern of soil and grout was the result of soil falling into the hole prior to grouting. The grout was strongly bonded to the canister wall and to the surrounding medium. The soil in contact with the canister wall was also bonded to it.

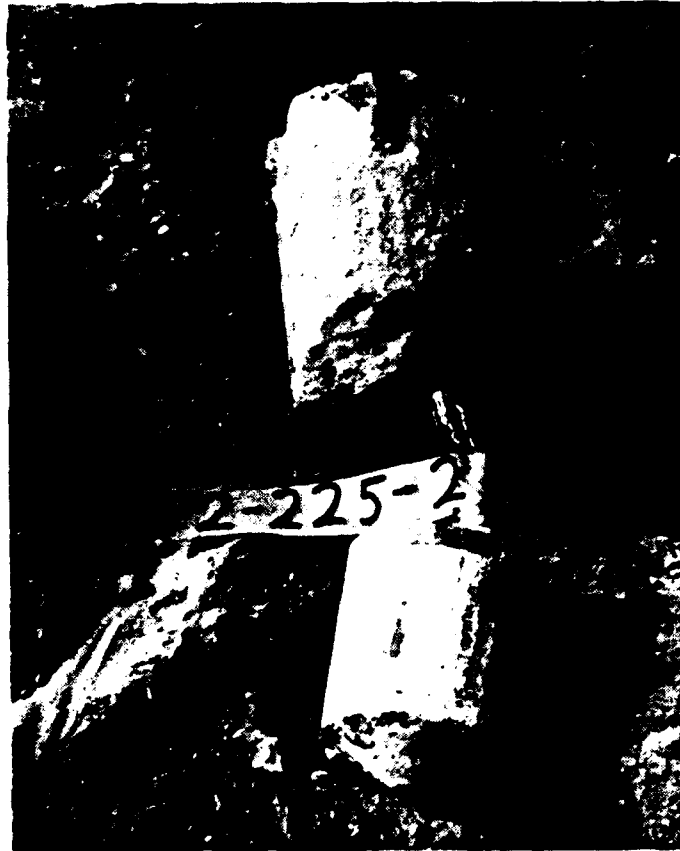
Figure 20. The 2-225-2 canister, fully excavated.

2-225-2: The canister was about 95% exposed. A small amount of grout was found in contact with the canister top surface. The result is that the canister was not grouted in.
